Resilient and sustainable

Building back after bushfires and floods

Progress has been slow after the 2009 Black Saturday bushfires, yet some people are now living in new homes built to higher standards, often with renewable energy systems designed to provide more backup in an emergency. We profile new homes in Yarra Glen and Marysville, plus, see how one Queensland flood rebuild is pushing hard for better standards on page 34. By Jacinta Cleary.

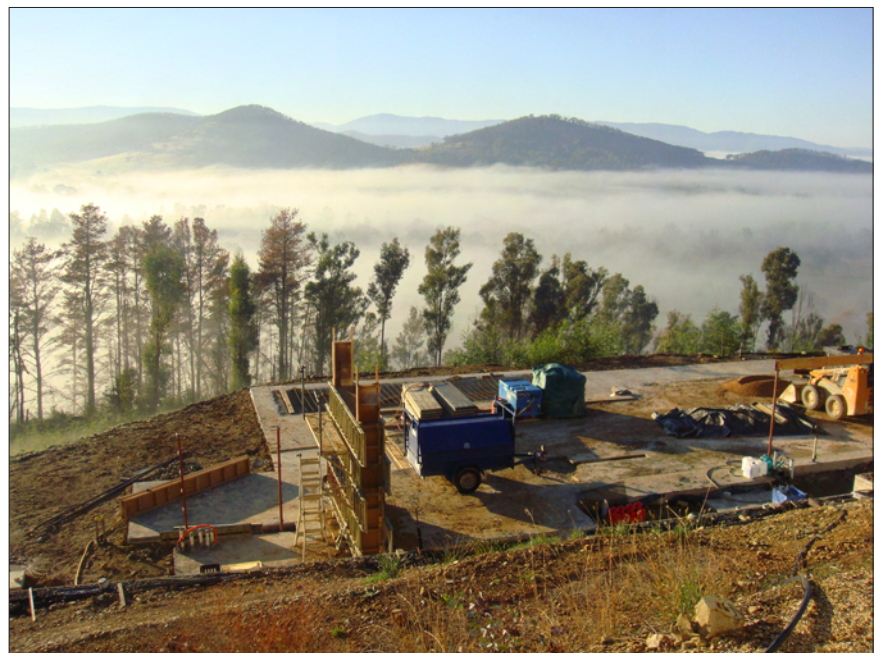
Early stages at the building site, where the old concrete slab was used for the rebuild.

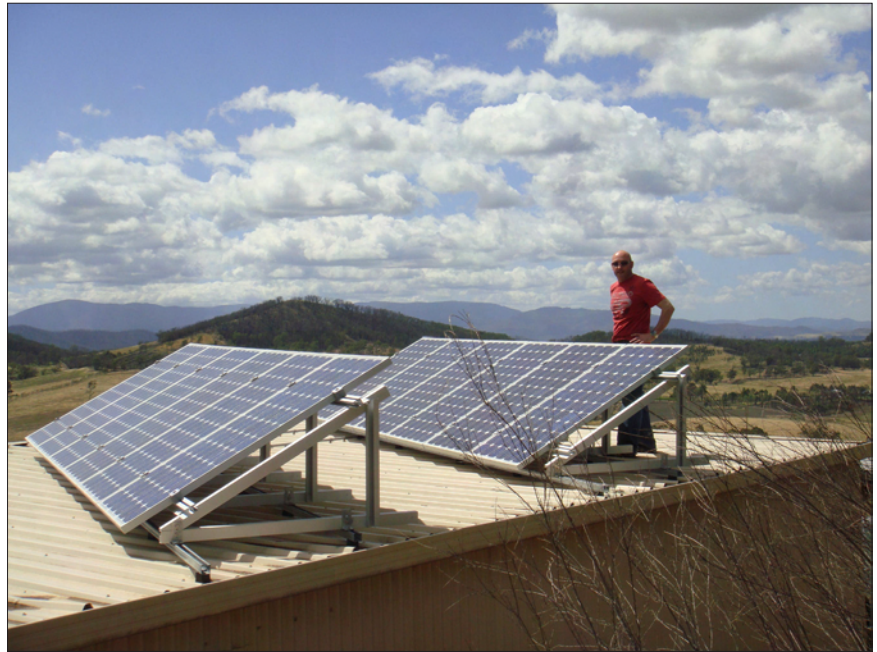
Top: The versatile grid-connect PV system can also operate independently thanks to a battery backup. Bottom: Beautiful and fire-resistant rammed earth walls on the western and northern sides during construction.

major delays from their electricity retailer. The system includes a Selectronic SP Pro 3500 watt, 24 volt interactive inverter, with 12 Narada EosG400 VRLA 2 volt gel batteries providing 6.7kWh of storage. This is understandably a bit of a security blanket for the couple if bushfires visit again, or just during regular blackouts.

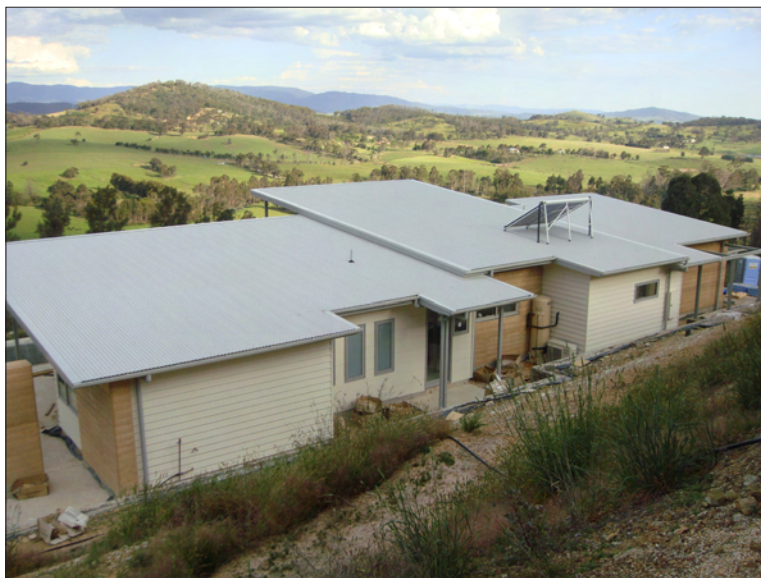
Top: A flat roof offers better resistance to ember attack in the future; Middle: Simple paving around the house offers more fire protection; Bottom: Rammed earth features inside the house along with louvres for better airflow.

which looks just like weatherboard. "The house felt solid and inside it felt grounded and safe." The couple engaged the designer of that house for their rebuild, heeding Ian Weir's advice to simplify the shape and opting for a flat, slightly angled roof profile that the embers would slide off. After all, the roof had been a weakness in the old house.

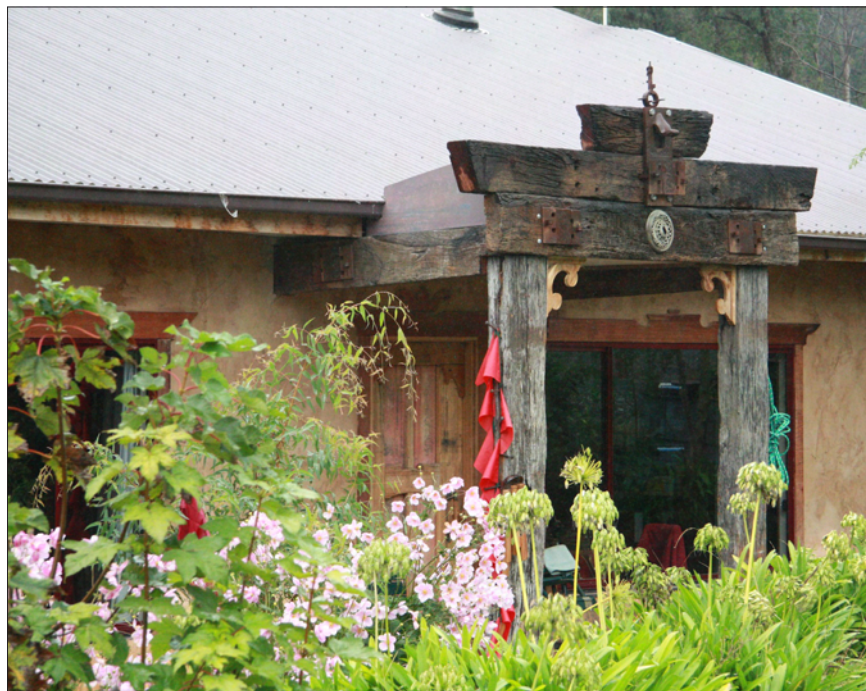
Cement sheet construction with an earth render help meet a BAL 19 rating.

resistant to future bushfires, and to be generally more energy efficient, the home and gallery is built on a concrete slab, with the main construction being concrete blocks and cement sheeting (or blueboard) with an earth render applied by Bruno. The windows are double glazed with aluminium frames, with commercial windows sourced at cost from the manufacturer Southern Star Windows. At the time, there were limited residential windows available to meet the fire rating, although this has changed (see windows article pg 38).

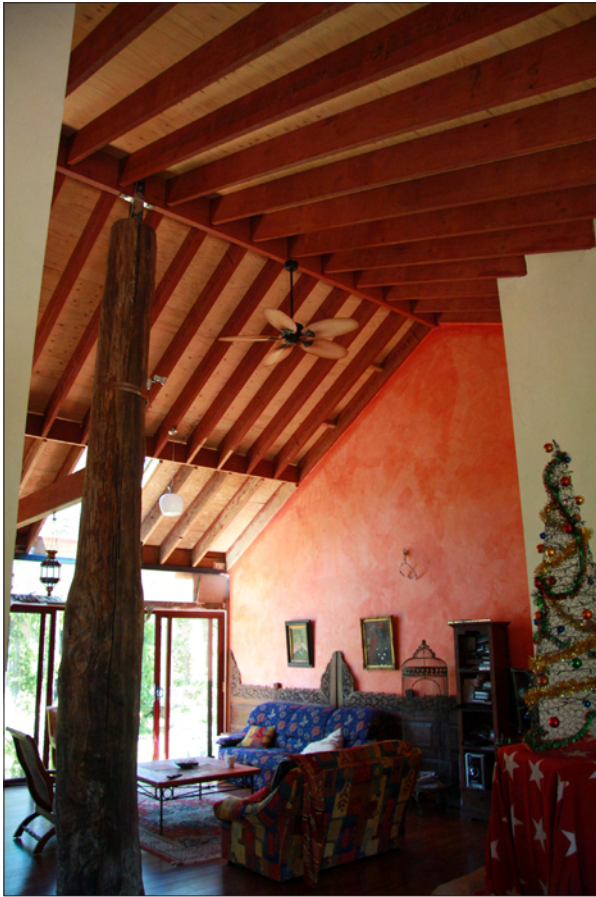
Top: The bushfire-felled tree post in Bruno’s new home. Bottom: This Marysville rebuild features cement-lined eaves to protect against future ember attack.

Both the house and gallery have a very crafty look and feel through the use of salvaged materials wherever possible, including a beautiful tree inside, felled in the fires and now used as a support post for part of the roof load. A batch of old posts from the old Princess Pier, left lying near the Westgate Bridge, have
